# Manhole Inspection Summary

Manhole # S17AA\_033MH

Insp Date: **11/19/07 4:26 PM**

**Location** Address: **2510 LAFAYETTE ST**

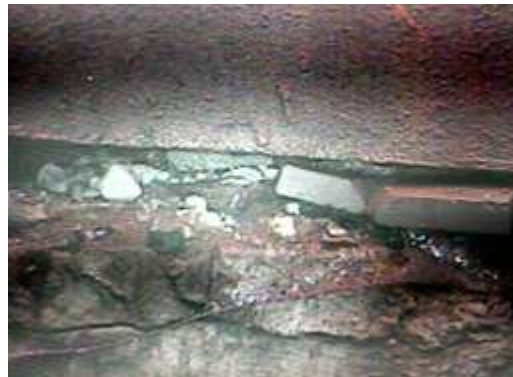
Defect 1

**Chimney / Frame Adjustment** ☒ Exists Material: **Brick** ☐ Parged Height: **3** (in.)

Condition: ☐ Sound ☐ Cracked ☐ Root Intrusion ☒ **Loose Brick** ☐ Deteriorated

ADJUSTMENT

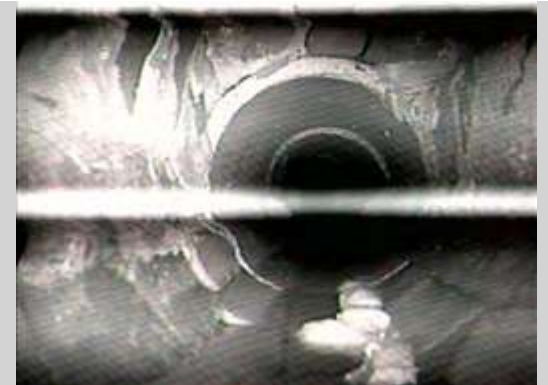
12 O'Clock Outflow

8 in. Circular Gravity Sewer  
Pipe Out @ 12 O'Clock

Pipe Height: (in.) Direct  
Pipe Material: **Clay** ☐ Pipe Lined  
Invert Depth: **9.80** (ft.) Flow Characteristics: **Slow**  
Deposits: ☒ None ☐ Mud ☐ Sludge ☐ Debris ☐ Grease  
Silt Depth: (in.) Deposits Extent:  
Infiltration: **None** Pipe Seal Cond: **Sound**

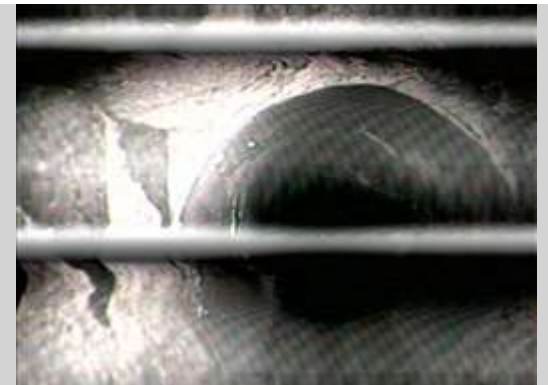
3 O'Clock Inflow

8 in. Circular Gravity Sewer  
Pipe In @ 3 O'Clock

Pipe Height: (in.) Direct  
Pipe Material: **Clay** ☐ Pipe Lined  
Invert Depth: **9.62** (ft.) Flow Characteristics: **Slow**  
Deposits: ☒ None ☐ Mud ☐ Sludge ☐ Debris ☐ Grease  
Silt Depth: (in.) Deposits Extent:  
Infiltration: **None** Pipe Seal Cond: **Sound**

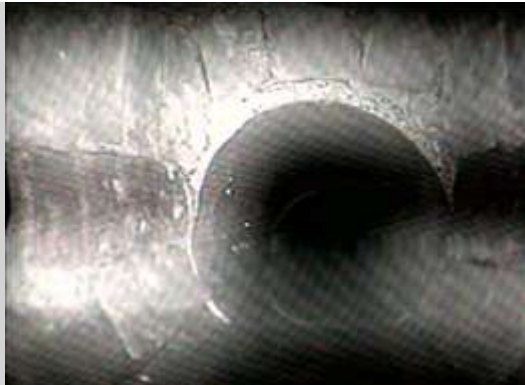
6 O'Clock Inflow

10 in. Circular Gravity Sewer

Pipe In @ 6 O'Clock

Connects To: **Stub connection / abandoned**

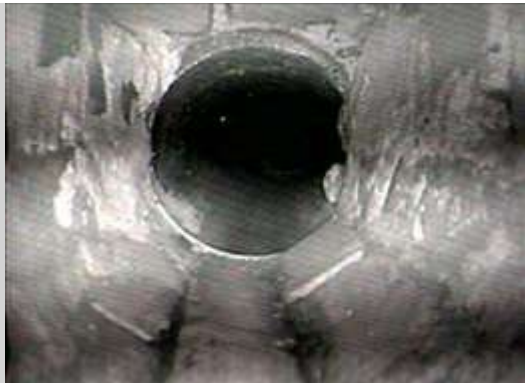
9 O'Clock Inflow

8 in. Circular Gravity Sewer

Pipe In @ 9 O'Clock

Connects To: **House connection / Service line**
